IRRIGATION IN MONTANA: A PRELIMINARY INVENTORY OF INFRASTRUCTURE CONDITION

PBS&J
1120 Cedar St
Missoula, MT 59802

January 2009

MONTANA DNRC
CONSERVATION & RESOURCE
DEVELOPMENT DIVISION
Resource Development Bureau
P.O. Box 201601
Helena, MT 59620

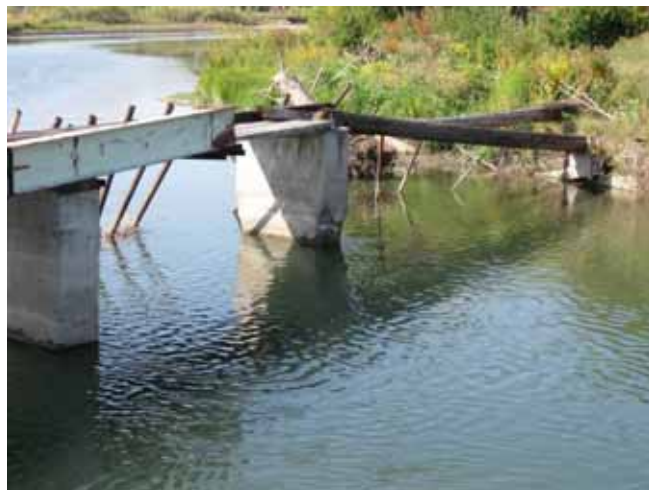
Trashrack in Front of Big Ditch Headgate

In front of the headgate structure is a makeshift trashrack intended to deflect logs and other debris away from the headgate control structure. According to the superintendent, the system works adequately during high flows and the trashrack keeps most debris away from the headgate structure. However, the trashrack appears to be in bad condition and needs to be replaced in some sections. For example, the concrete piers are cracking and the middle support is almost destroyed. The wooden planks used to access the structure are in need of replacement and not structurally sound. Several steel pipes are rusted out and no longer effective.

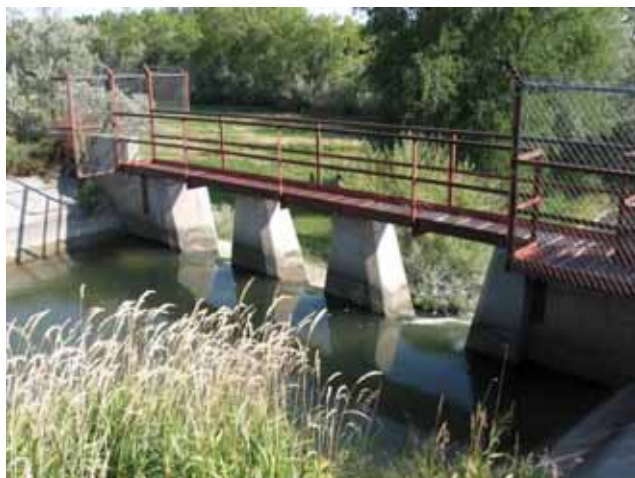
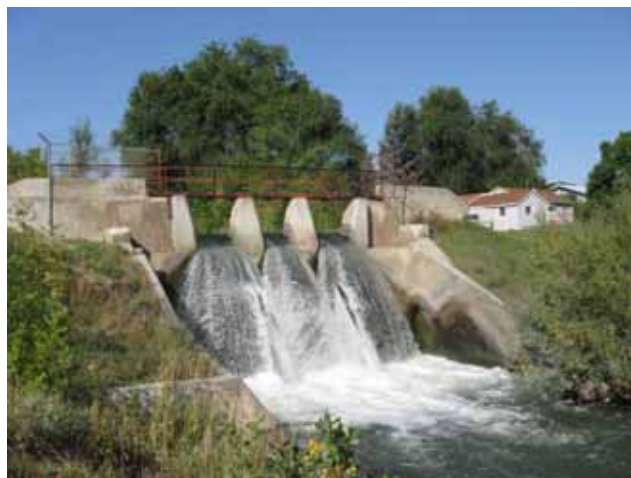
Laurel Drop Structure

The four drop points on the Big Ditch system are all similar. These structures are used to dissipate energy as water drops from a higher elevation to a lower one. All four of the drops are made of concrete and are in very good condition. Some of the drops have been recently upgraded or fixed. Overall, these structures are functioning properly and in good condition.

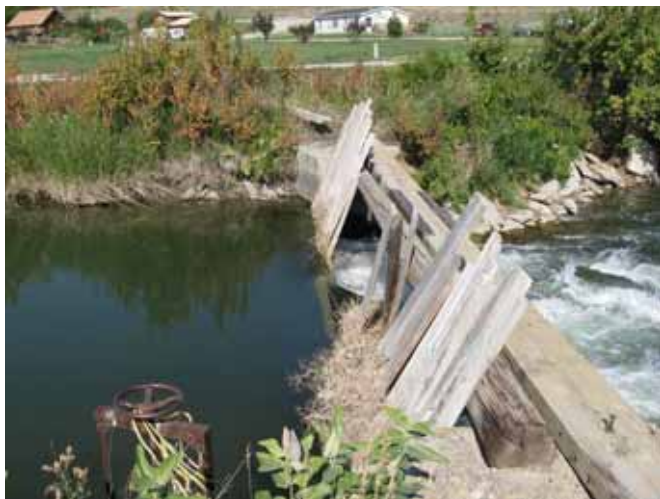
This is a point in the ditch where boards are placed to create a backwater effect. The backwater effect is used to fill a distribution ditch. This is a crude system and could be upgraded for better control.

Benner's Check structure used to get water into distribution ditch headgate that can be seen in foreground of the photo.

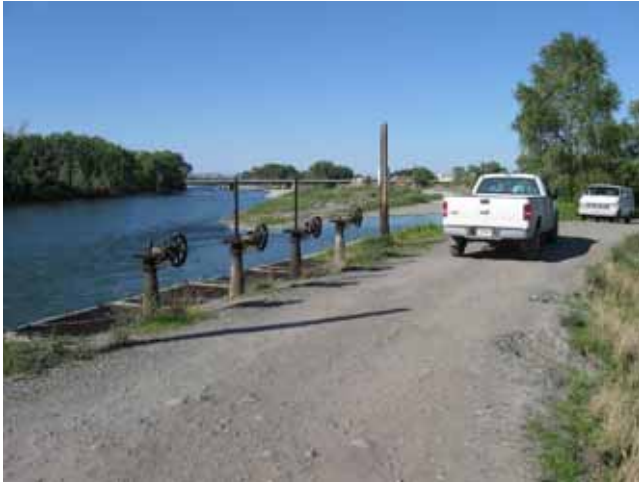
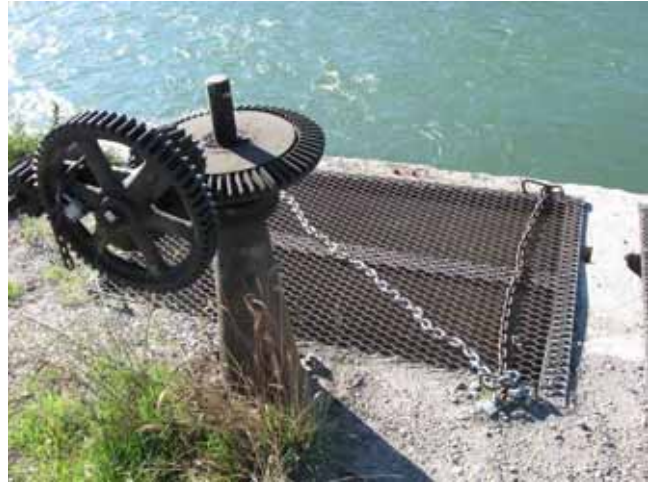
Billings Bench Headgate

The headgate control structure consists of four large metal slide gates. A hand crank is used to open and control the gates. This system seems to work adequately as long as the gates are only being moved less than one foot at a time. During the beginning and end of the season, a small truck is used to open and close the gates. This requires the ditch operators to remove the wheel of the truck and use the crank shaft to open and close the gates. During emergencies, the amount of time required to operate the gates is a safety issue. An upgrade of the gate control mechanism would be advisable.

There is no apparent deterioration of concrete in the headgate structure. Overall, the initial takeout point is in good condition but could use some updating on certain components.

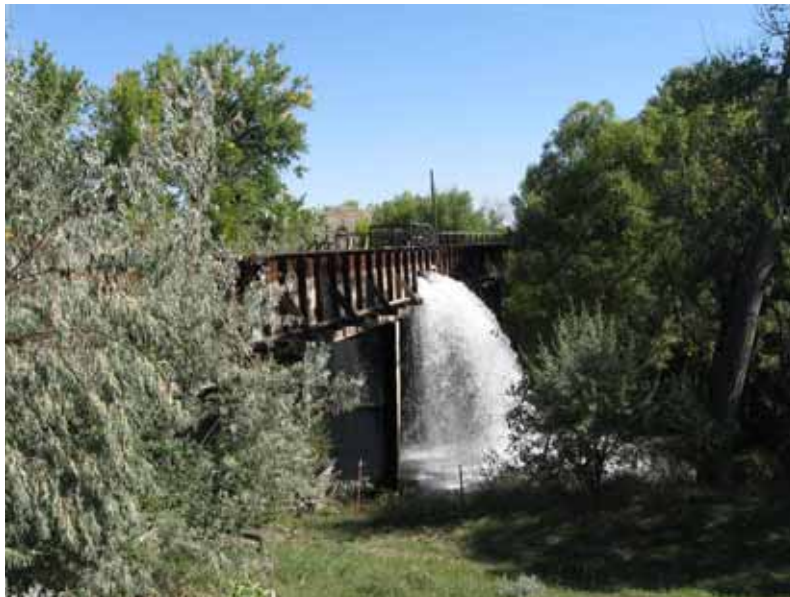
Canyon Creek Flume

A large wooden flume is used to convey the ditch across Canyon Creek which is on Billings West end. The structure was built in the 1940's and according to the ditch operators works rather well. There are a total of four head gates located in the middle of the flume. These head gates help control the level of the ditch. However, even with all four of the head gates open, the water level in the ditch is not adequately reduced. This has been a cause for concern in case of an emergency. The only way to shut off the ditch completely is at the initial diversion.

The overall structural integrity of the flume looks good. The large concrete piers that carry the load were intact and the frame was in good condition. The walking deck and planks need to be replaced and a structural assessment would be beneficial. A staff gauge directly downstream of the flume allows the ditch operators to judge the flow in the system at this location. However, the staff gauge has not been calibrated for a number of years.

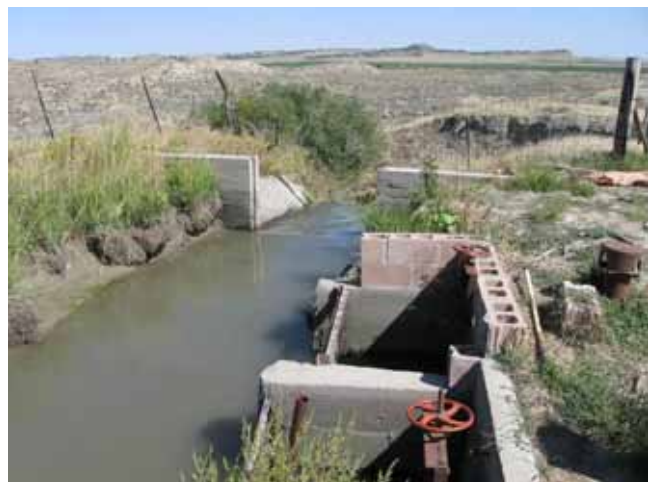
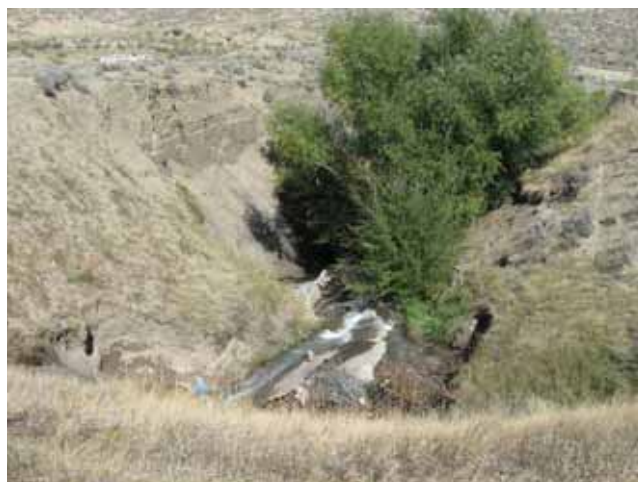
End of the Billings Bench Canal

The Billings Bench Canal terminates at a small coulee east of Shepherd. At this point, the ditch flows about five cubic feet per second (cfs) compared to the approximately 500 cfs that is originally diverted out of the Yellowstone. A few structural issues in this area could use some attention. For example, the large concrete spillway that helps direct the out-flow down into the coulee has collapsed and needs replacing in order to reduce erosion issues.

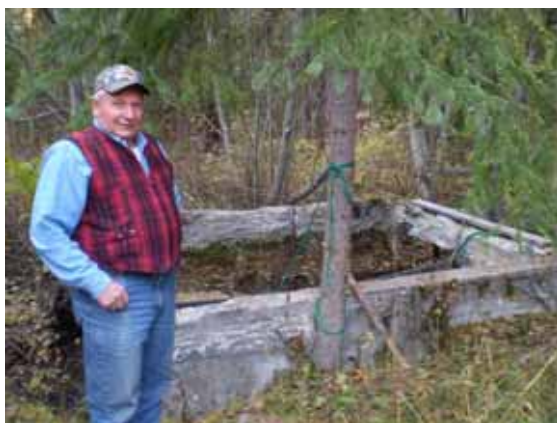
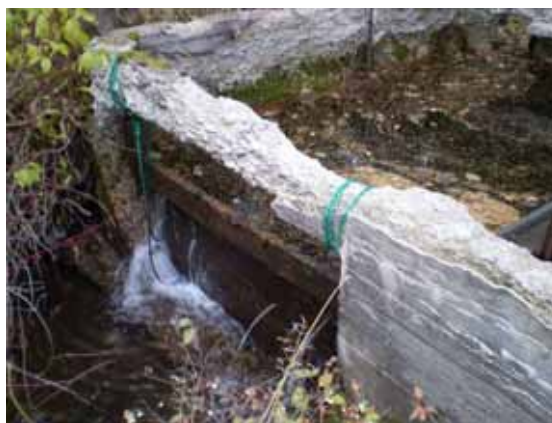
Ed’s Creek Diversion Structure

The Ed’s Creek Water Company diverts water out of Ed’s Creek approximately seven miles south of Alberton in western Missoula County. It is a small system that irrigates about 100 acres. The diversion structure is a concrete box constructed across the stream channel. The box functions to raise the water level high enough to fill an 8-inch pipeline. The concrete structure is badly deteriorated.

The concrete box is divided in half by a screen to prevent debris from entering the pipeline. The users have placed boards along the stream channel to keep the water flow directed toward the concrete diversion structure. This diversion system is very make-shift and is not likely to last much longer.

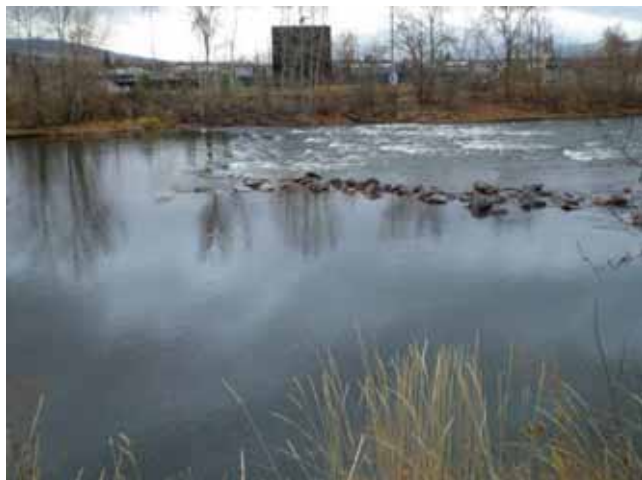
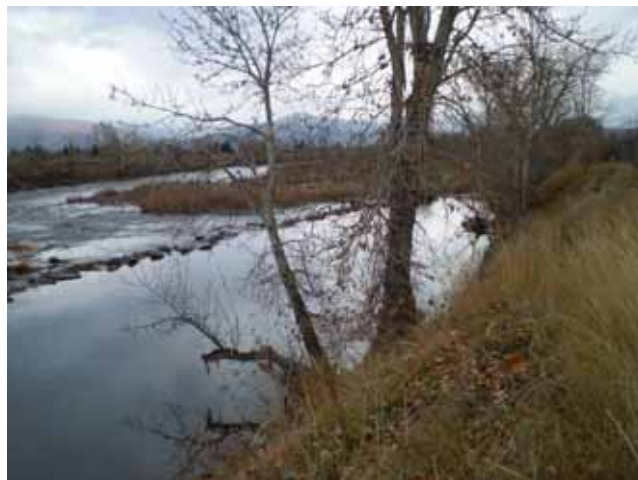
Hellgate Valley Canal Diversion Dam

The Hellgate Valley Canal diverts water from the Clark Fork River near downtown Missoula. The company's diversion dam is comprised of rock rip-rap that runs closely parallel to the direction of flow creating a channel on the north side of the river directing water towards the flow control structure.

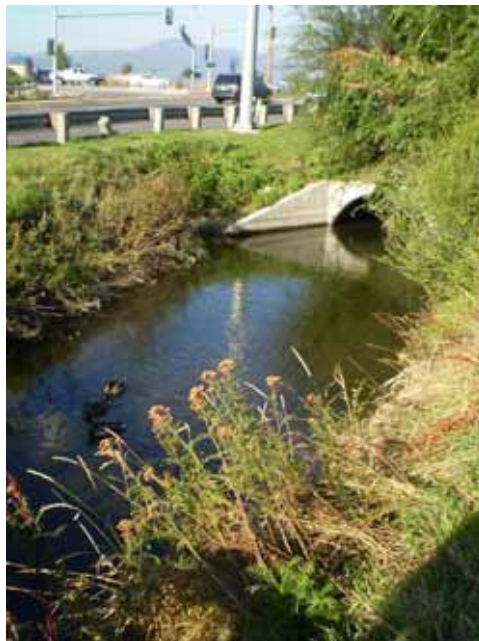
Culvert Under the Intersection of Mullan Road and Reserve Street

The control structure consists of two culverts, both with 2-foot diameters. There are no gates on this structure so water is allowed to flow into the system without check. Furthermore, a small beaver population chokes the channel with debris and plugs the culverts on a regular basis

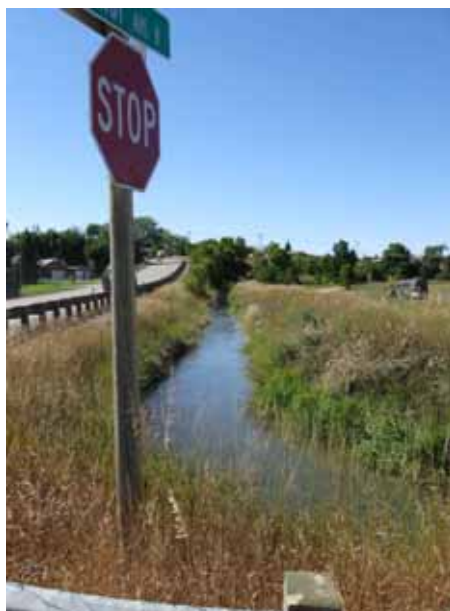
Ditch Running Parallel to Highway

The ditch runs parallel to a local trailer park and there has been some controversy over seepage issues. Some residents have complained to the ditch company about flooding in the crawl spaces under their homes. If seepage from the ditch is the cause of the flooding problems, lining the section of the ditch adjacent to these residences may resolve the issue.

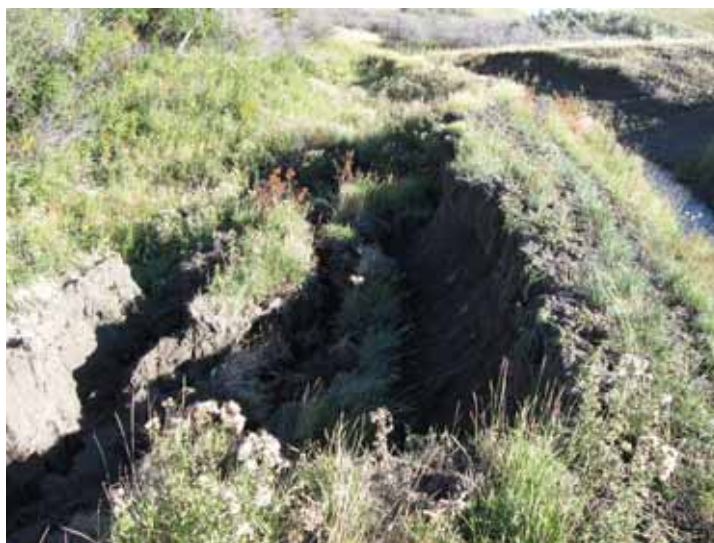
Erosion Issues Along Ditch Bank

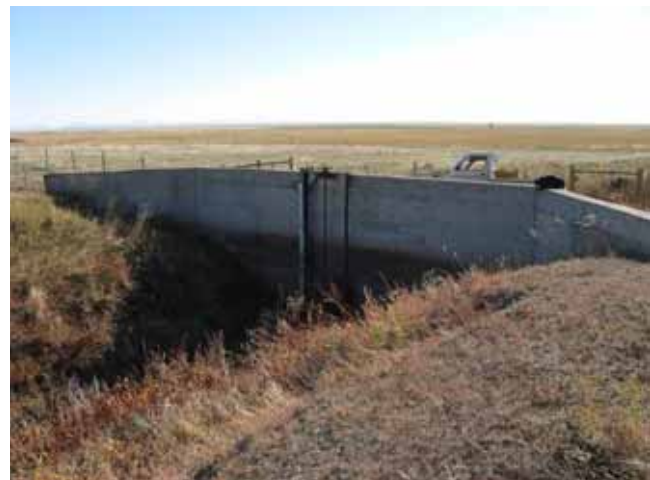
A View of the Dike System

The North Chinook Reservoir About is located about 6 miles down ditch from the initial diversion. This storage facility consists of dikes built up to hold water back from the adjacent farmland. It covers approximately 500 acres. This facility was created in 1915 and is the backbone of the system for several water users in the area. The facility and its related infrastructure are in good condition.

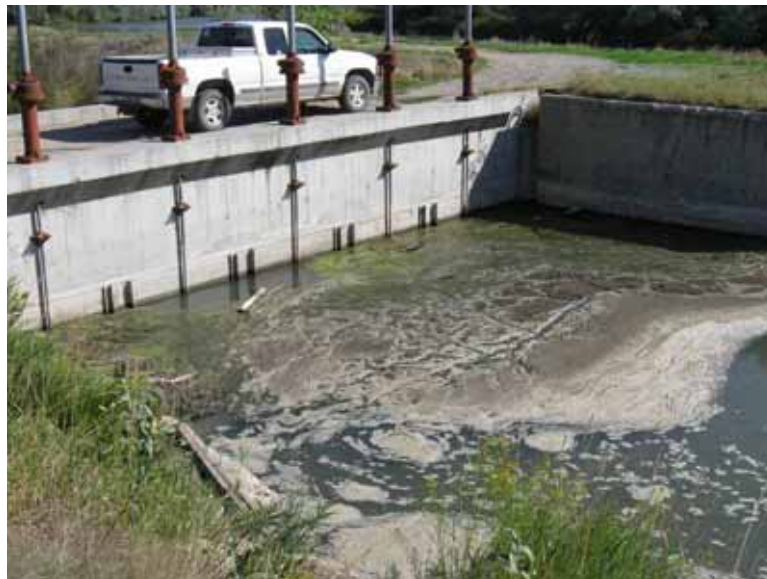
Two Leggins Canal Headgate

The concrete structure and the rip-rap adjacent to the headgate are in good overall condition. There are some minor cracking issues due to the freeze thaw cycle associated with a northern climate. However, large amounts of pond weed and moss choke the system and cause maintenance issues. The Two Leggins Ditch does have a moss collector about half a mile downstream from the diversion point.

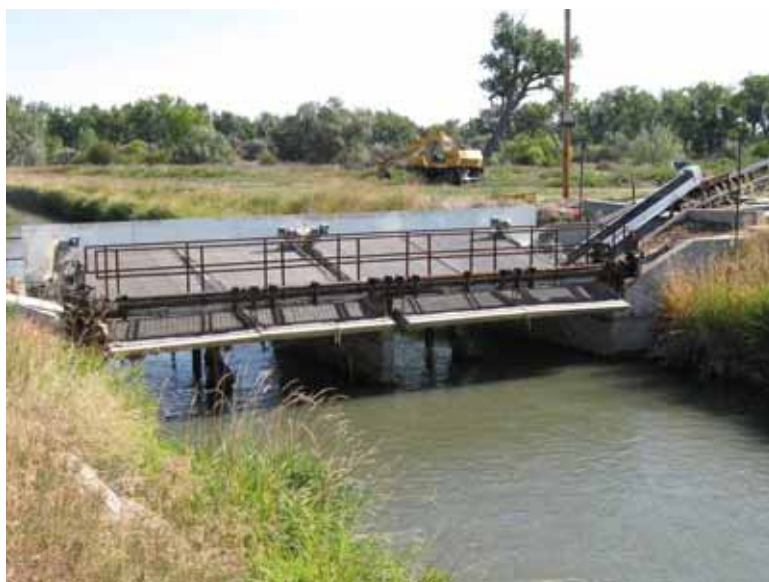
Moss Catcher Unit

About one hundred yards down ditch from the secondary control structure is a \$350,000 moss catching machine that is used to keep the ditch flowing properly. It was reported that the unit is relatively maintenance free and is a crucial structure to keep the ditch in working order.

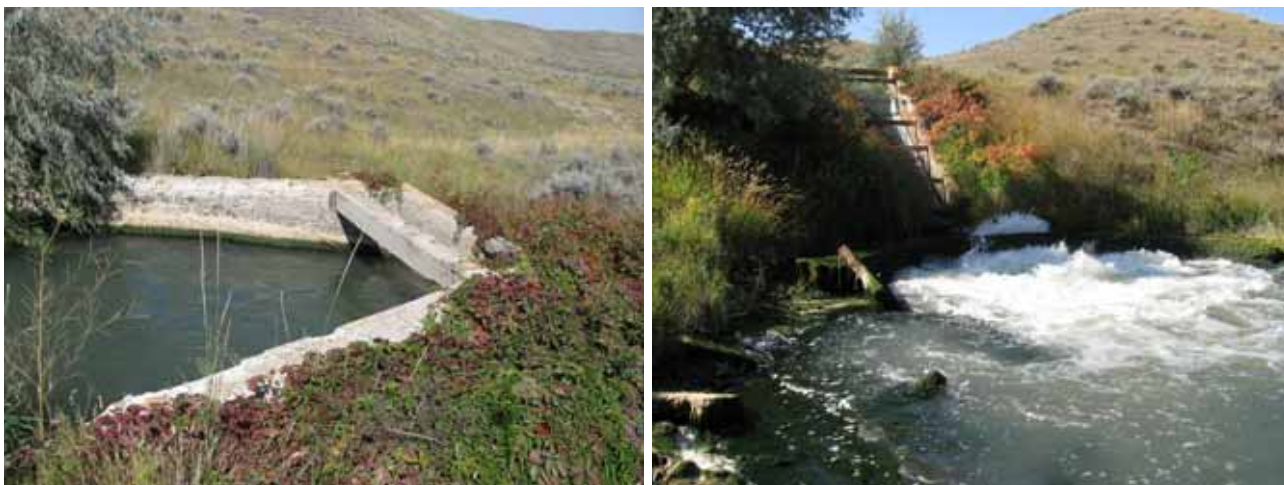
Two Leggins Canal Drop Structure North of Interstate

very poor condition. The concrete has deteriorated to the point where re-bar is exposed. A new drop structure that does a better job of dissipating flow energy would reduce maintenance and bring this component up to good operating standards.

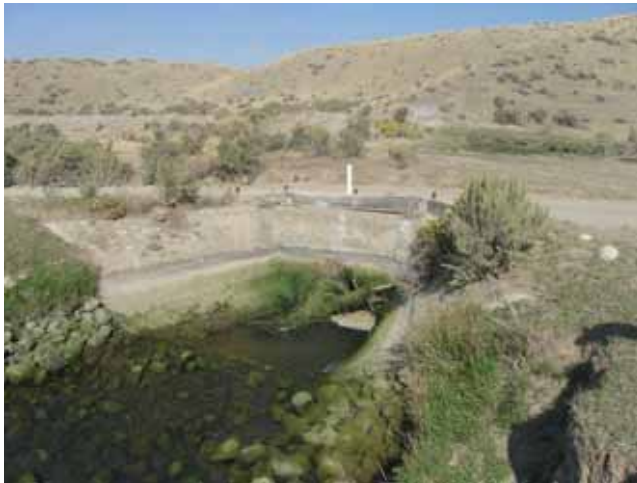
Anderson Siphon Entrance

There are eleven siphons on the Vigilante Canal system. Most of the siphons have 4-foot wide entrances made of concrete. All the siphons are in good working order and provide excellent conveyance throughout the system. The two longest siphons on the system are the Alder Creek Siphon and the Elser Siphon. Each is approximately $\frac{1}{4}$ mile in length. Maintenance at these sites was reported to be fairly low, mainly consisting of debris removal and moss treatments.

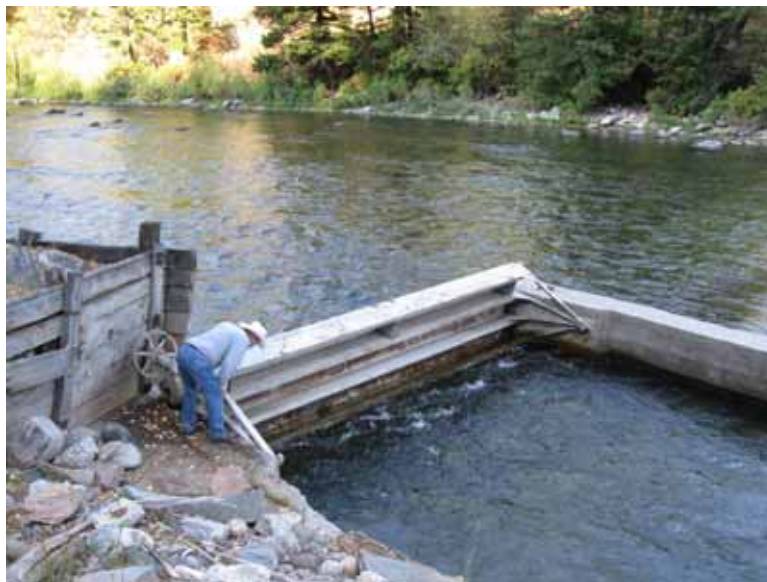
West Gallatin Canal Radial Gate at Diversion

The West Gallatin Canal Company diverts water from the Gallatin River about six miles south-southwest of Gallatin Gateway. The initial diversion includes a concrete diversion dam that spans the width of the river and a large metal radial gate at the head of the canal channel. The radial gate is controlled by a cranking system which raises or closes the gate. Although the gate is in good condition, the diversion dam is inadequate. During low flows, it fails to create enough backwater effect to get water into the canal. The ditch company is exploring the idea of working with kayak enthusiasts to re-construct the diversion dam to serve as a water park and to improve flows into the canal.

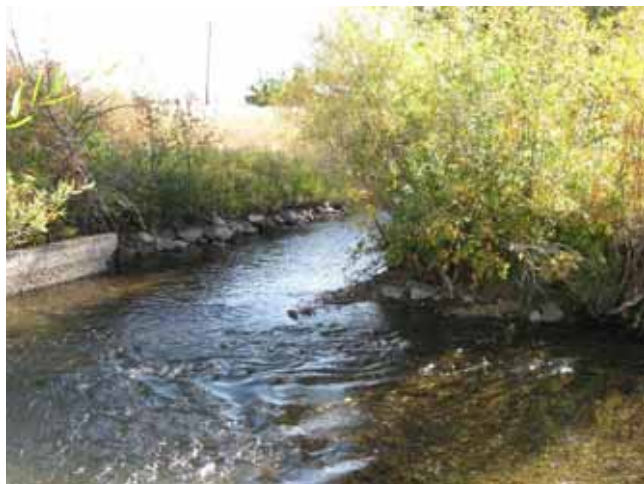
Big Bear Creek is another example of the entry point-exit point type stream crossing. The structures in this area were poorly designed to begin with and are now old and deteriorating. The operator must place boards in the check structure from the bottom up. This causes gravel, sediment and debris to build up. When it comes time to remove the boards, they must be dug out. Additionally, the ditch channel must be excavated regularly to maintain conveyance in the ditch.

Bear Creek Entry Point (creek enters from right, in foreground)

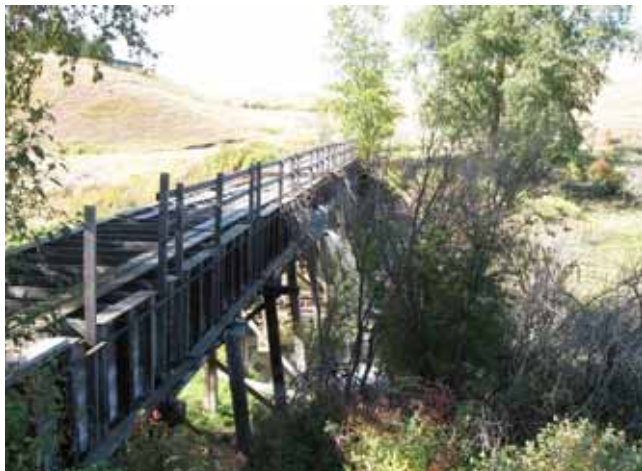
A large flume is used to convey the canal over Dry Creek. The flume and support structures are made of wood. There is a leak at the entrance of the flume which is slated for repair. The flume is about 150-200 ft long and is lined at the entrance and exit with rubber matting. The rubber matting looked to be in good condition. In the center of the flume, a small head gate allows ditch operators to release water into Dry Creek to regulate flow in the ditch or in the event of an emergency. Although the structure is old, it still operates adequately.

Wooden Flume – Spillway Visible in Center
