WILLOW CREEK DAM

Fact Sheet

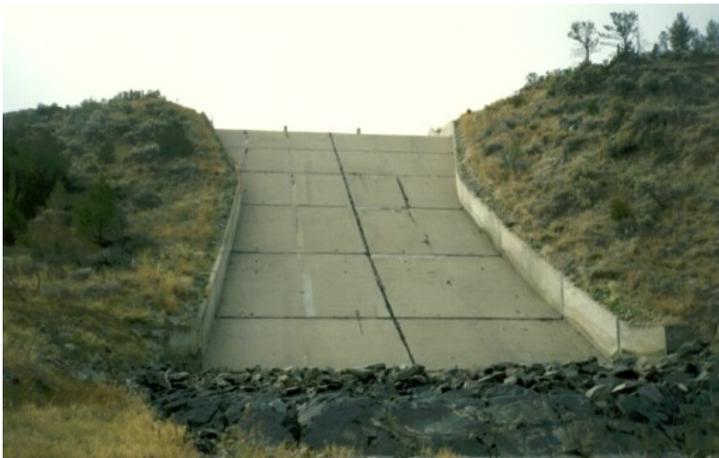
Spillway

- ◆ The spillway does not meet current safety standards. Concrete deterioration exists in the spillway wall and floors. A reservoir level restriction was implemented in 2018. The spillway will require replacement in the near future. Estimated costs to be determined based on pending feasibility study.
- ◆ The road around the reservoir that is used to access the dam and gate tower is difficult and sometimes impossible to navigate in the spring and winter.
